Environmental Test Report

High Output, High Efficiency LED Luminaire Part Numbers: SLM35573A1S0 and SLM35573A2S0

Customer Name: RSM Electron Power, Inc.

Test Report No.: R-15491-1

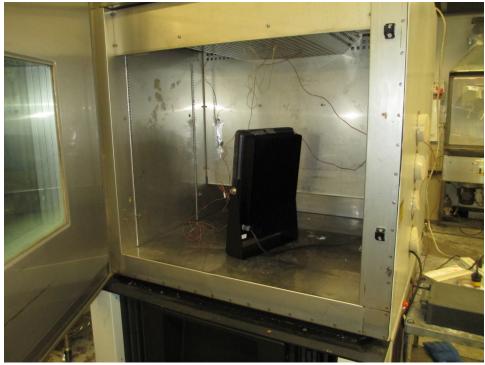
Test Setup, Internal

TEST DATA SHEET		
Test Meth	od	Temperature Cycling		
Customer		RSM Electron Power, Inc.		
Job Numb		R-15491		
Test Samp		High Output, High Efficiency LED Luminaire		
Part Numb		SLM35573A2S0		
Serial Nun		0006	•	
Test Spec		MIL-STD-883	Method: 1010.	8
Operating	Mode	Mode 2		
Technicia	n	N. Mirabile		
Date		3/18/15 through 3/23/15		
Notes:				
Date	Time	Test Log		
3/18/15	11:45	With the EUT operating in Mode 2 the chamber temperature was decreased to -40 at a rate of	of 2°C per minute.	_

12:20	Once the chamber reached -40°C, the EUT was dwelled for 30 minutes.		
	12:50	The chamber temperature was increased to 55°C at a rate of 2°C per minute.

13:35	Once the chamber reached 55°C, the EUT was dwelled for 30 minutes.		
	14:05	The chamber temperature was decreased to 25°C at a rate of 2°C per minute.		
		The above steps constitute 1 cycle and repeated 24 additional times for a total of 25 cycles.		
3/23/15	8:30	The EUT was visually inspected and functionally tested.		
		Complete Temperature Cycling test.		
	There was	s no apparent visual damage noted as a result of this test. The EUT operated pro	nerly during and a	
Results:		n of testing. The High Output, High Efficiency LED Luminaire met the requirement

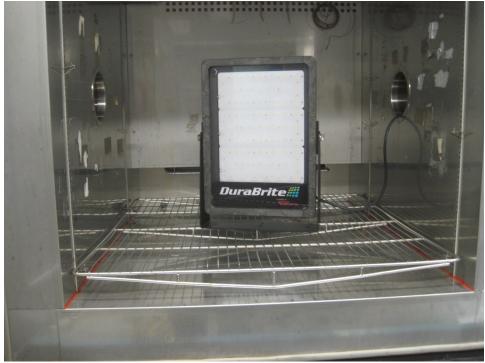
Test Setup, Internal

TEST DATA SHEET	
Test Meth	od	Moisture Resistance	
Customer		RSM Electron Power, Inc.	
Job Numl		R-15491	
Test Sam		High Output, High Efficiency LED Luminaire	
Part Num		SLM35573A1S0	
Serial Nu		0047	
Test Spec		MIL-STD -883	Method: 1004.7
Operating		Mode 1	motilod: 1004.7
Technicia		N. Mirabile	
Date		3/26/15 through 4/7/15	
Notes:		3/20/13 tillough 4/1/13	
	Time	Total on	
Date	Time	Test Log	
3/26/15	11:00	Began setup for Moisture Resistance Test.

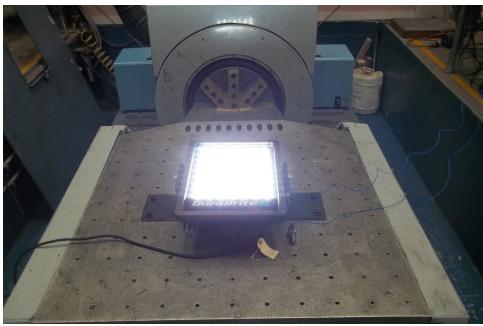
Z Axis

Date	Time	Test Log
3/13/15	15:07	Begin Z-Axis Resonance Search
		Complete. No resonances noted.
	15:11	Begin Z-Axis Cycling
		Complete.
	16:20	Begin Y-Axis Resonance Search
		Complete. No resonances noted.
	16:23	Begin Y-Axis Cycling
		Complete.
	19:30	Begin X-Axis Resonance Search
		Complete. No resonances noted.
	19:34	Begin X-Axis Cycling
		Complete.
Results:	There v	vas no apparent visual damage noted as a result of this test. The EUT operated properly after test. The High High Efficiency LED Luminaire met the requirements of the Luminaire Vibration test.
	•	Sheet 1 of 4

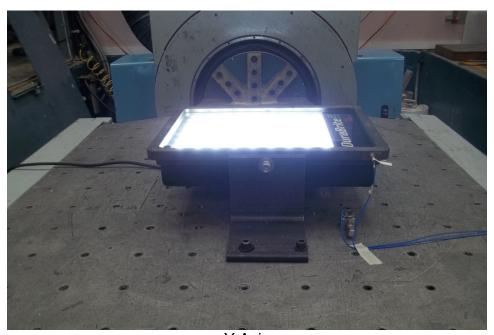
Y Axis

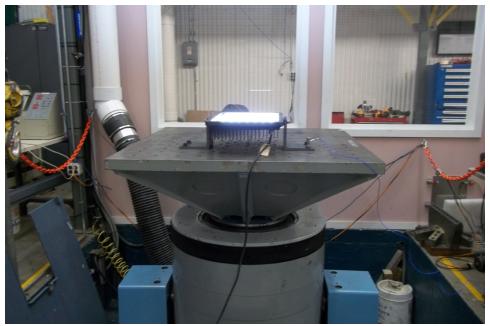
X Axis

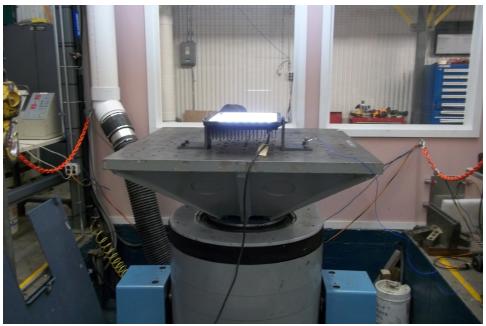
X Axis

Mechanical Shock Pulse Shape: Half Sine Axes Tested: X, Y, Z Shock Pulse Duration: 11ms Polarities Tested: Positive and Nega Peak Acceleration: 30g Shocks/Axis: 6 Shocks / Axis Date Time Test Log 3/14/15 9:04 Begin X-Axis Positive and Negative Complete 10:16 Begin Z-Axis Positive and Negative Complete 10:23 Begin Y-Axis Positive and Negative Complete Complete Complete There was no apparent visual damage noted as a result of this test. The EUT operated properly during a			4/1	14/13					
Pulse Shape: Half Sine Axes Tested: X, Y, Z Shock Pulse Duration: 11ms Polarities Tested: Positive and Nega Peak Acceleration: 30g Shocks/Axis: 6 Shocks / Axis Date Time Test Log 3/14/15 9:04 Begin X-Axis Positive and Negative Complete 10:16 Begin Z-Axis Positive and Negative Complete 10:23 Begin Y-Axis Positive and Negative Complete 10:23 Begin Y-Axis Positive and Negative Complete Tomplete There was no apparent visual damage noted as a result of this test. The EUT operated properly during a	Notes:

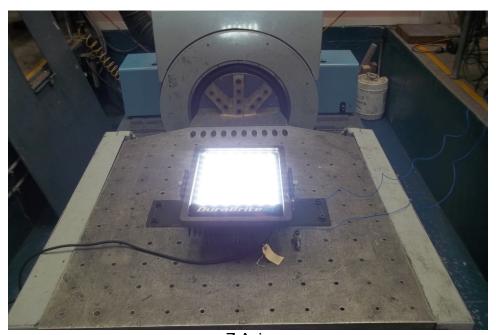
Z Axis

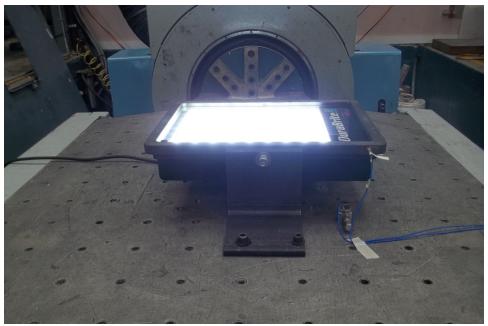
Y Axis

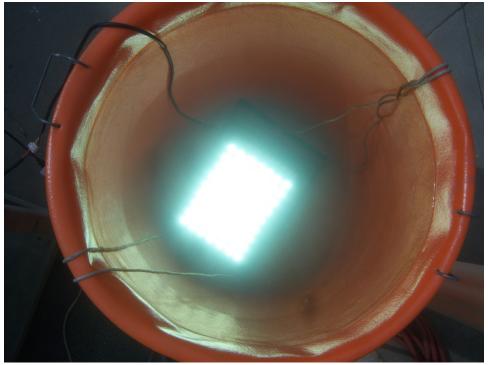
Test Setup

TEST DATA SHEET
Test Meth	od	Temporary Immersion
Customer	•	RSM Electron Power, Inc.
Job Numb	oer	R-15491
Test Sample		High Output, High Efficiency LED Luminaire
Part Num	ber	SLM35573A1S0
Serial Nui	mber	0047
Test Spec	ification	IEC 60529 Para: 14.2.7
Operating		Mode 2
Technicia		L. Stoddard
Date		3/25/15
Notes:		
Date	Time	Test Log
3/25/15	14:42	Began the Temporary Immersion Test.
		With the EUT placed into operating Mode 2, it was lowered into a vat containing 1 meter of water.

-		These conditions were maintained for 30 minutes.
		The height of the water was measured from the bottom of the EUT.
		The lens of the EUT was face up during this test.

15:12	The EUT was removed from the water.
		The EUT was visually inspected and functionally tested.
	15:30	Completed the Temporary Immersion Test.
	-	
Results:	exposu	vas no apparent damage visually noted as a result of this test. The EUT operated correctly during and after and showed no sign of water penetration. The High Output, High Efficiency LED Luminaire met the nents of the Temporary Immersion test.

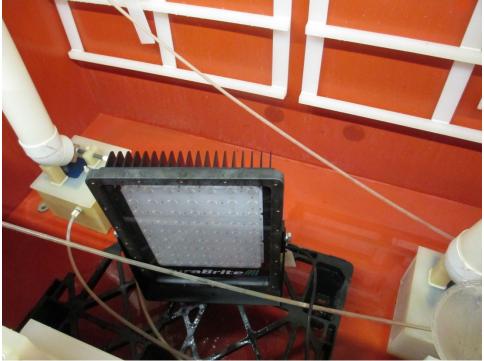
Test Setup

TEST DATA SHEET							
Test Method	Test Method Salt Spray / Corrosion Resistance						
Customer	omer RSM Electron Power Inc.						
Job Number	R-15491						
Test Sample	High Output, High Efficiency LED Luminaire						
Part Number	SLM35573A1S0						
Serial Number	0048						
Test Specification	ASTM B 117-09, ASTM D1654-08						
Operating Mode	Mode 1						
Technician	N. Mirabile						
Date	3/30/15 through 4/12/15

Percentage Of Salt In Solution: 5%	Acceptable pH Range: 6.5 to 7.2	Fallout Rate: 1.0 to 3.0 ml/80cm ² /hr	Water Type: DI	
Length of Exposure: 240 Hours	Drying Time: N/A	Chamber Temperature: 35°C	Resistivity 1-18 M Ω

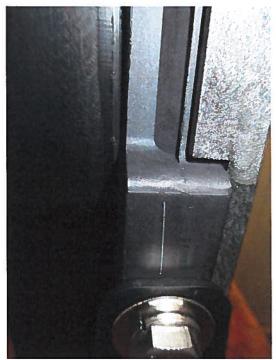
Pre-Test, Scribed Lines, Photograph 2

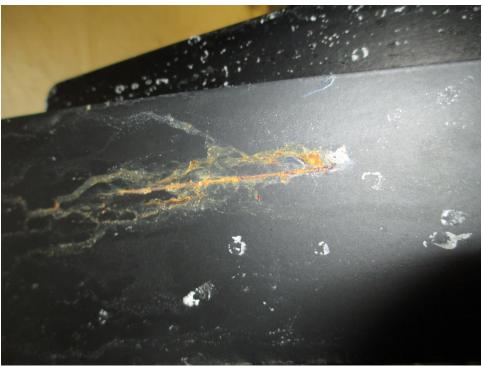
Post-Test, Scribed Lines, Photograph 1

D-4-	T !	- Bu	Temperature	D 0.14	Fallout Rate ml/(80)cm/hr			
Date	Time	PH	in °C	Percent Salt 1	1	2	3	4
3/31/15	11:20	6.9	35	5	1.1	1.2	1.2	1.2
4/1/15	11:20	6.9	35	5	1.2	1.5	1.4	1.2
4/2/15	11:23	6.8	35	5	1.3	1.2	1.5	1.2
4/3/15	11:25	6.9	35	5	1.1	1.1	1.2	1.1
4/4/15	11:20	7.1	35	5	1.1	1.1	1.2	1.1
4/5/15	11:30	7.0	35	5	1.1	1.2	1.1	1.2
46/15	11:20	7.0	35	5	1.1	1.2	1.1	1.2
4/7/15	11:20	6.9	35	5	1.2	1.1	1.0	1.2
4/8/15	11:30	6.9	35	5	1.0	1.3	1.5	1.2
4/9/15	11:30	6.8	35	5	1.1	1.2	1.5	1.2
4/10/15	11:20	6.9	35	5	1.0	1.3	1.5	1.2
	0	0.0		-	st Log			
3/30/15	11:00	The tempera		•	he salt solution was s	prayed.		
0,01,10	11:20	The EUT was	as scribed in 3 pla nour Salt Spray T	aces prior to testir				
4/10/15	11:30	Began purg	e of Salt Fog cha	mber.	omer arrival for post i			
4/13/15	14:25	The EUT wa	as rinsed with wa of the EUT had	ter and it was det a rating of 9 for ru	ermined the EUT had usting outside the scri	no blistering outsided line.	de the scribed line.

alt Spray Test.	rusted in areas ti	here was no scribed li	nes.		
Results:					EUT as a result of equirements of the S			
	I						SI	neet 1 of

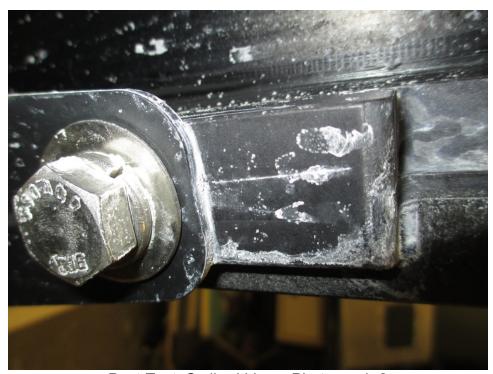
Post-Test, Scribed Lines, Photograph 2

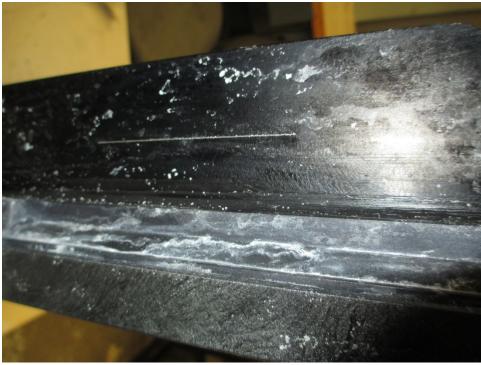
Post-Test, Scribed Lines, Photograph 3

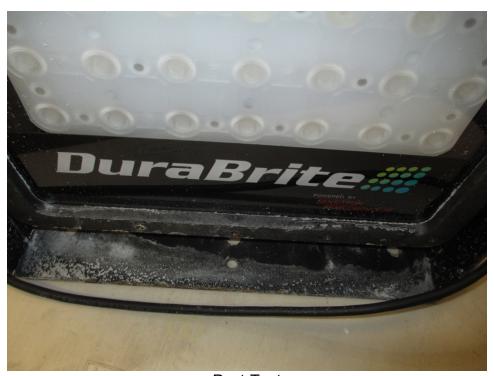
Post-Test
