Repairing or replacing Passport II, ECU, or Cabin mate control systems

Cabin Mate, Passport II and ECU systems were part of Marine Air's original control line of low-cost controls. These systems were made from about 1994 until 2004 although some were sold on boats as new as 2008. Micro-Air no longer supports nor can help diagnose these systems so the following information is provided to assist you in assessing your system and problems you may have.

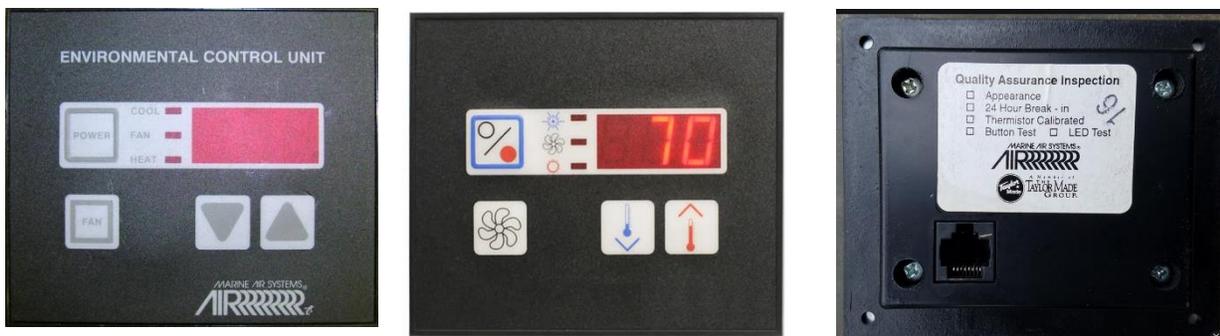
Figure 1

Displays for these systems looked similar to figure 1. Some had ECU written on top while others have a penguin in the lower portion of the display. There were no serial numbers on the back of the displays. Some display also came in white or silver but all had a similar button configuration and style.
